Case Studies of Zebra Mussel Control at Raw Water Intakes

Presenter:
Mark Hardie, P.E.
Senior Project Manager
HR Green, Inc.

Case Study #1 – Milford Municipal Utilities, Milford Iowa

Case Study #2 – Raw Water Improvements, Spirit Lake, Iowa

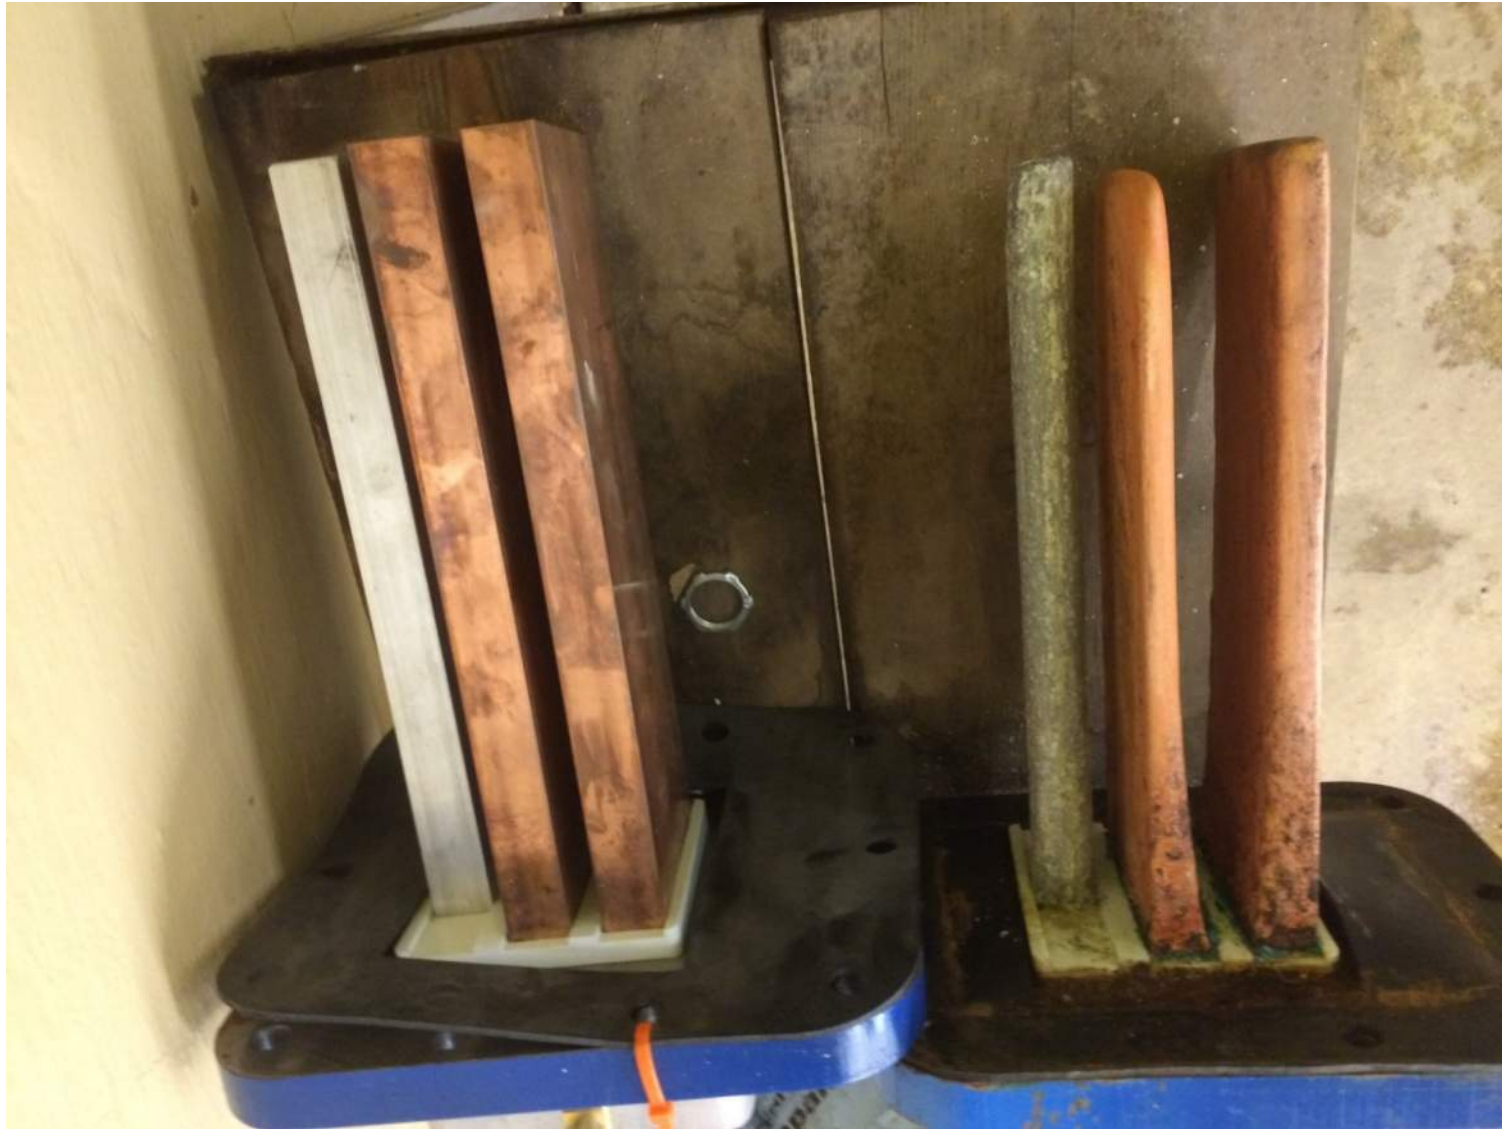
NEW ANODES

ORIGINAL ANODES (22 MONTHS)

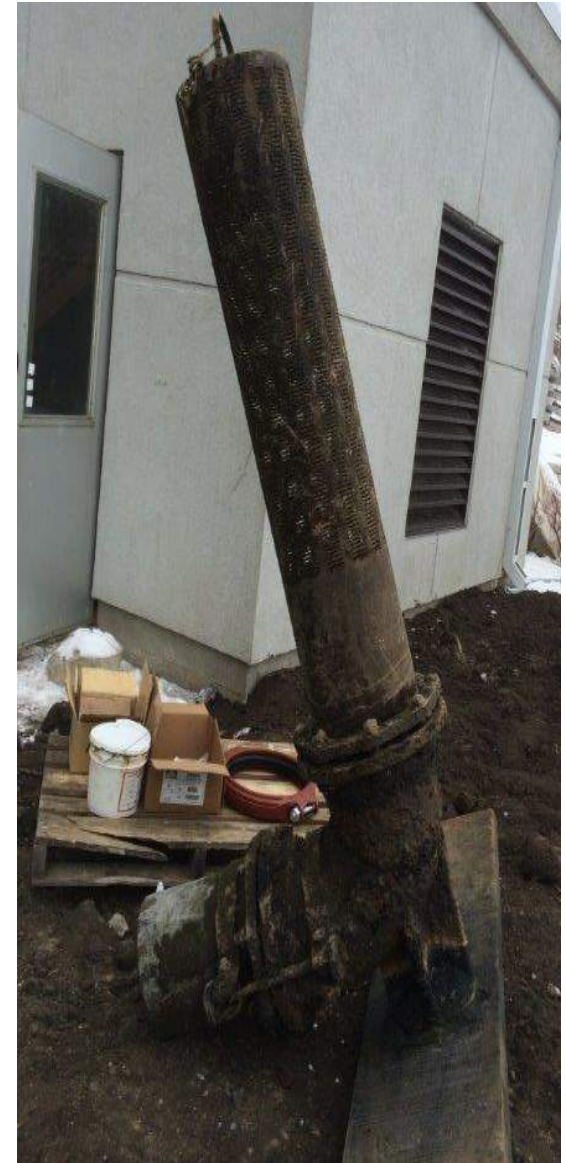
- MMU has existing 10-inch screened intake pipe and Pump house building on West Okoboji Lake
- Project included:
 - New 16-inch intake pipe
 - New copper Z-alloy™ screens on existing and new intake pipes
 - Chemical feed lines to inject copper ion solution at end of intake pipes
 - Hydroburst system to clean intake screens

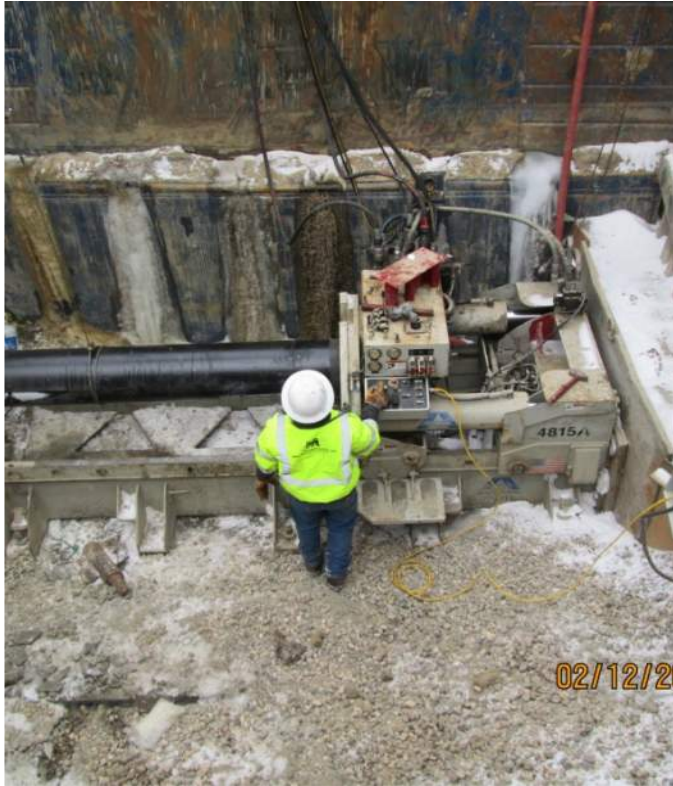
Installing the new 16-inch pipe from shore

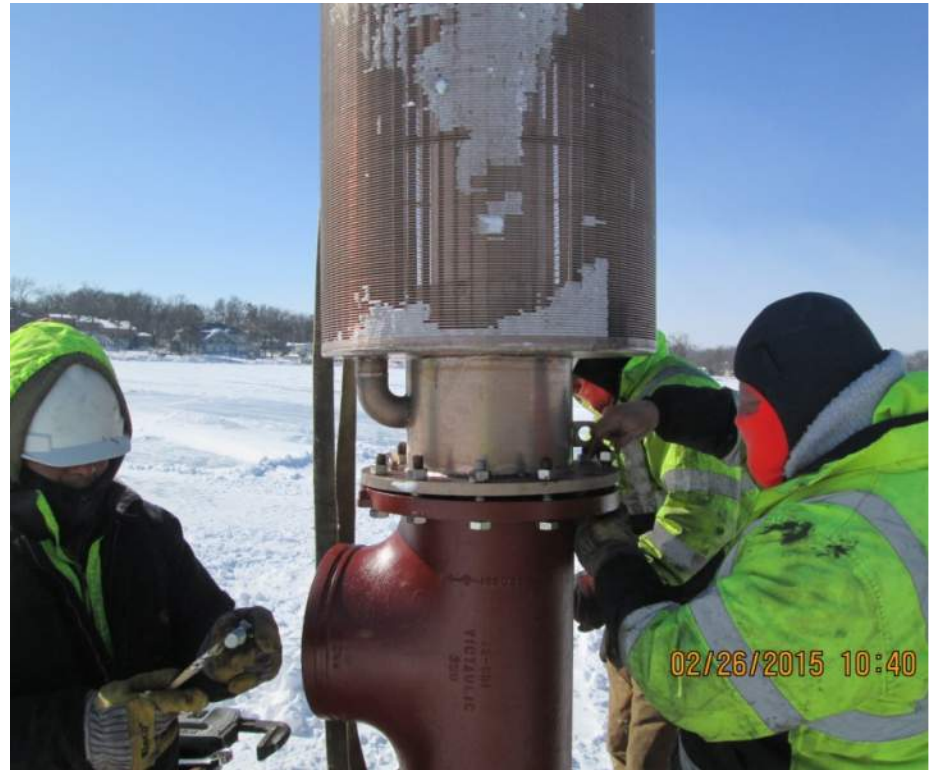
Assembling new 16-inch intake screen

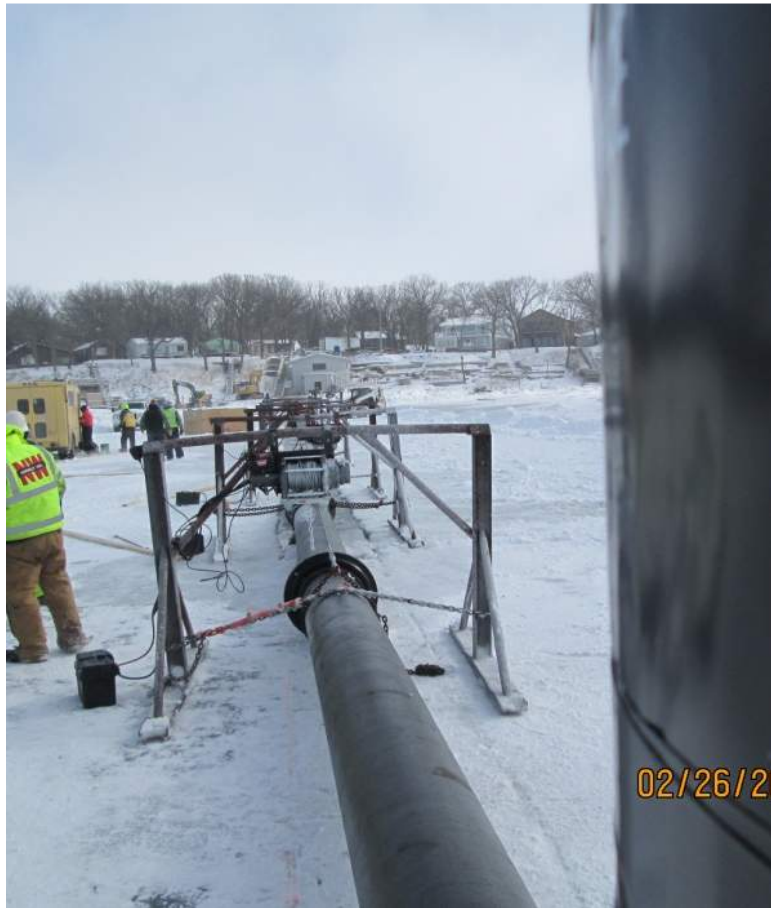
Laying out intake piping on frozen lake

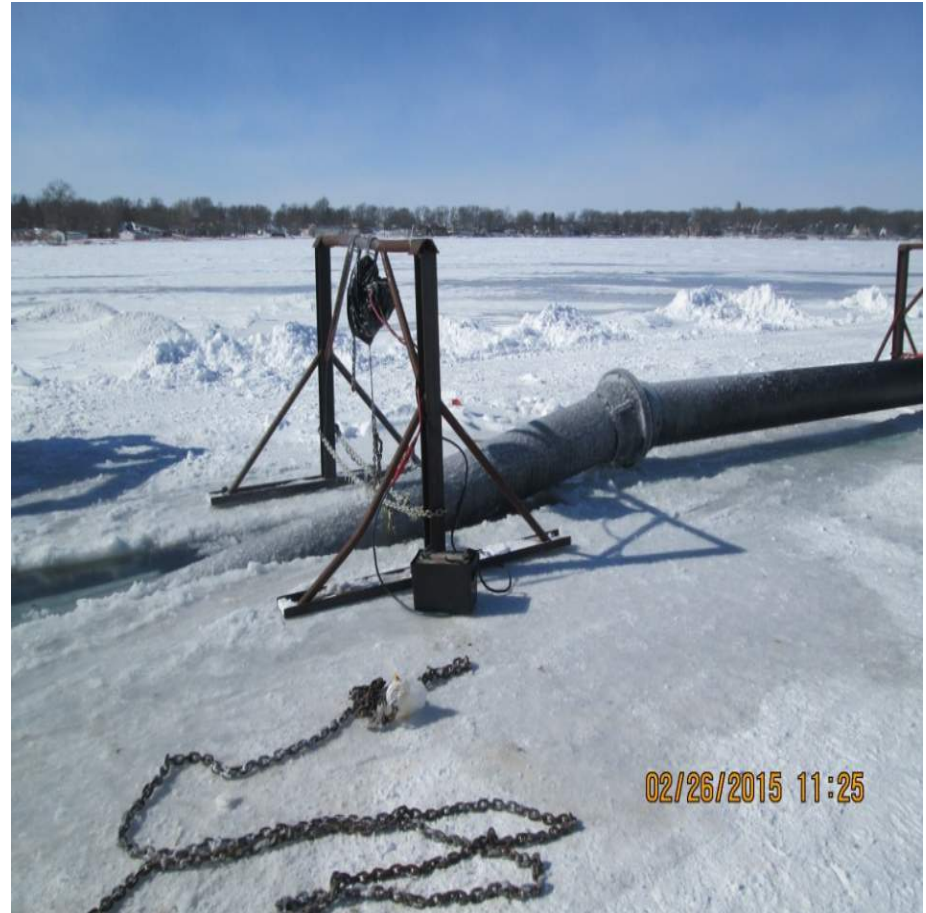
Lowering intake pipe through ice

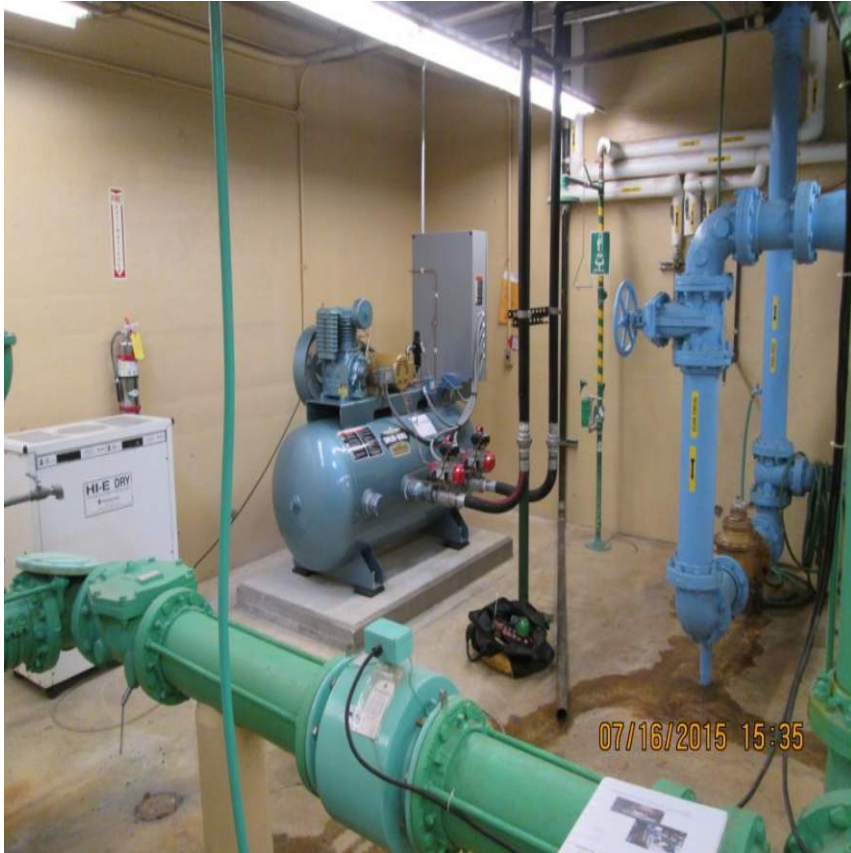
Hydroburst tank inside Pumpouse Building

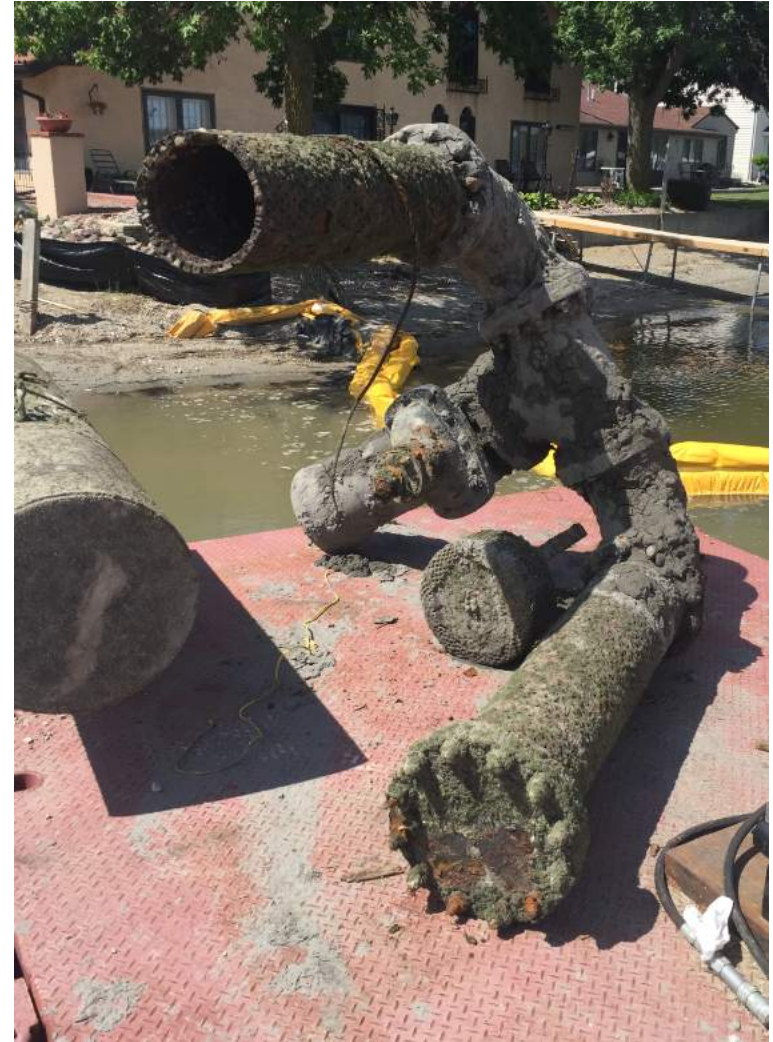
- Spirit Lake had 10-inch and 18-inch screened intake pipe and Pumphouse building on Big Spirit Lake
- Project included:
 - New 18-inch intake pipe
 - New copper Z-alloy™ screens on existing and new intake pipes
 - Chemical feed lines to inject copper ion solution at end of intake pipes
 - Hydroburst system to clean intake screens

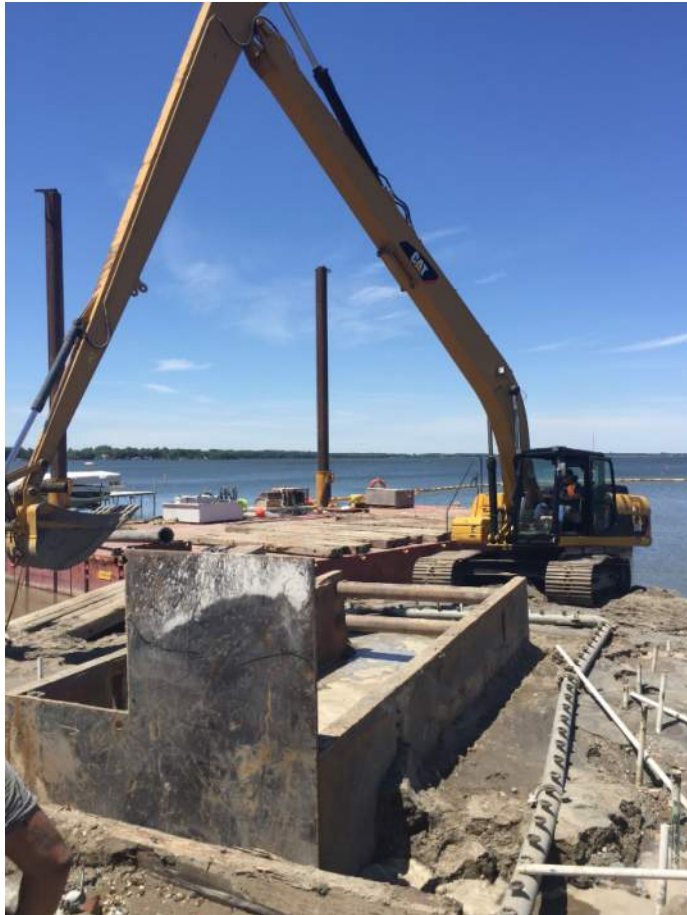
Dewatering at shore

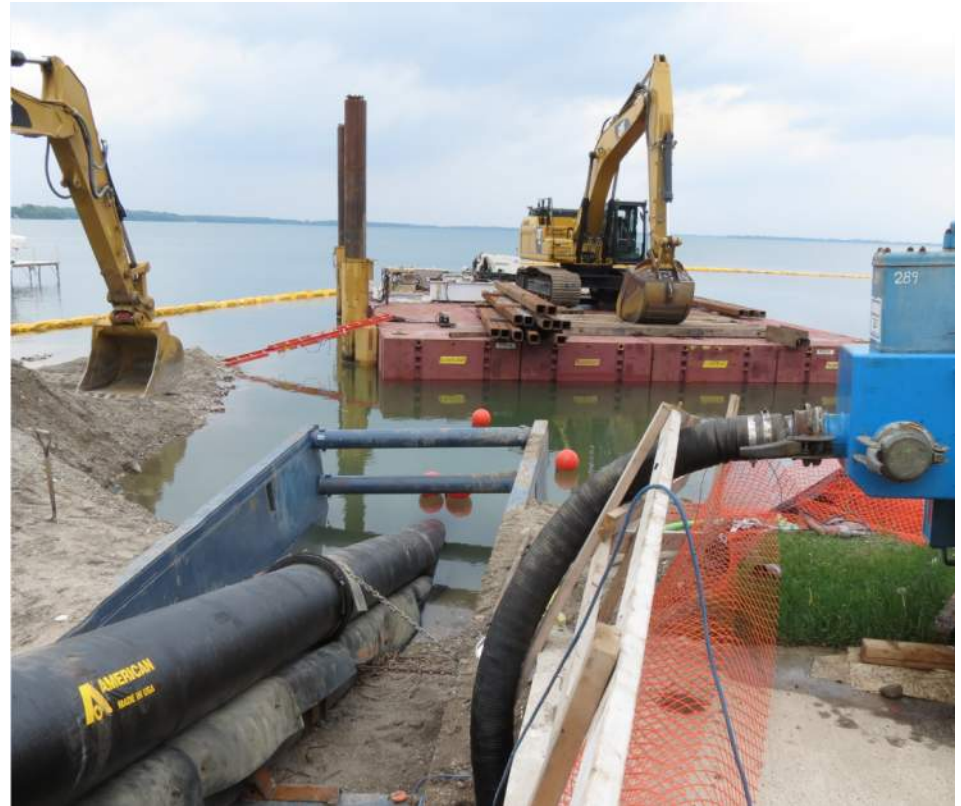
Initial setup for installation of intake line

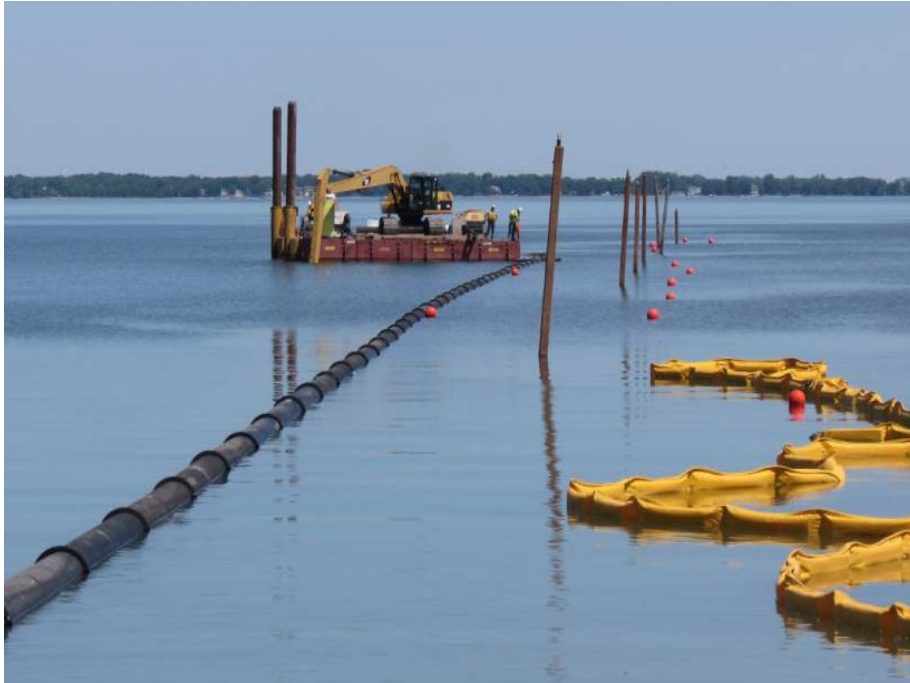
Installation of intake line

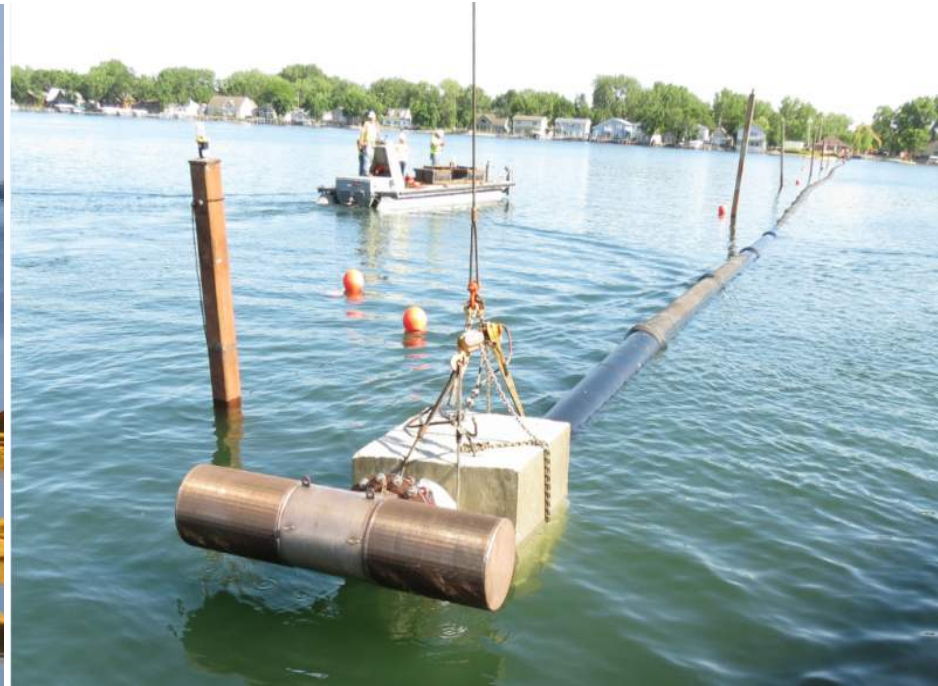
Installation of intake screen

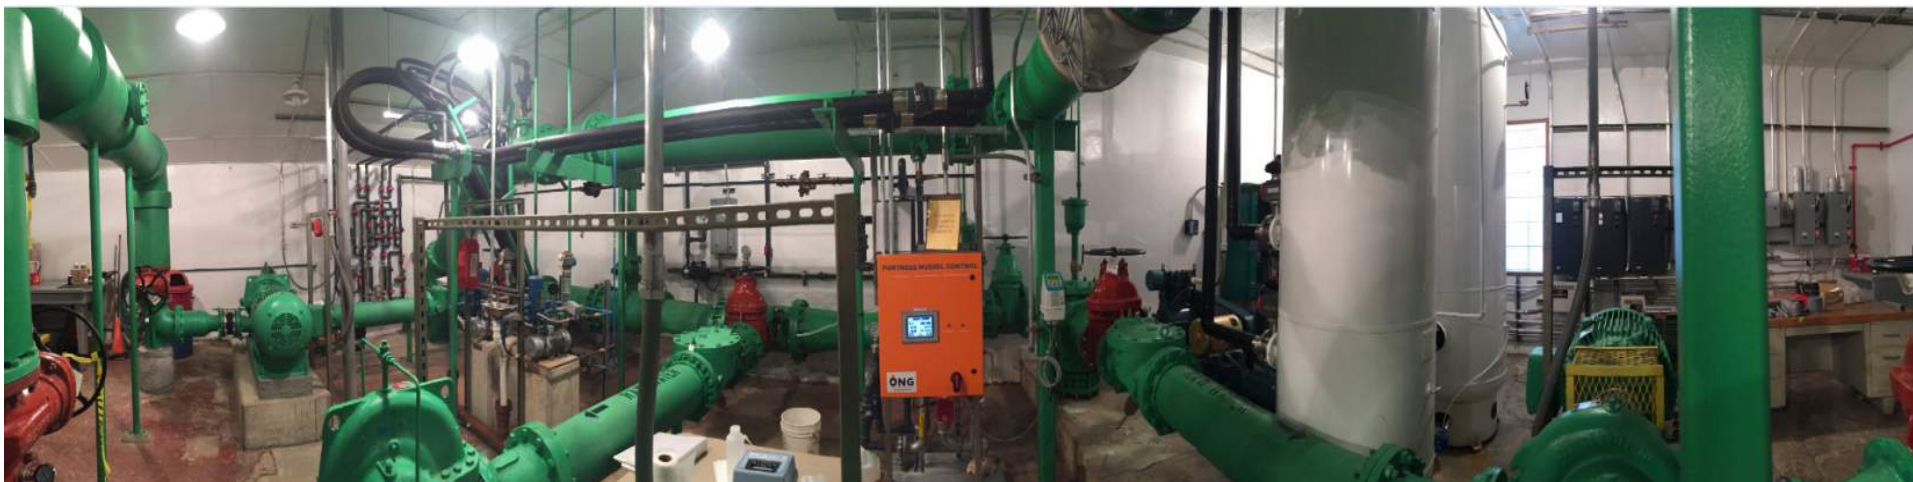
Panoramic of inside pump station
